THE OFF-SIDE UNDO

June 2025

English Motoring Club of Mississippi

3 Similar Cars, 3 Different Solutions

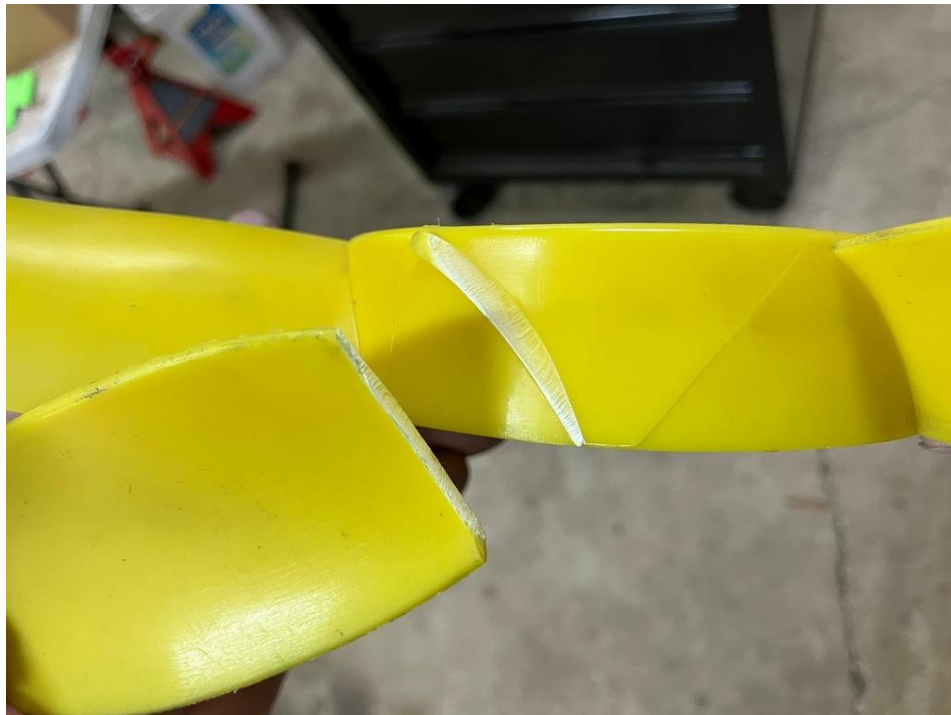
On the way back from Glore's May gathering, Bro Clay shucked a blade off of the engine cooling fan on his MGB. The good thing is the incident happened while he was idling up his driveway on his way home. Luckily, no damage was done to his hood or radiator.

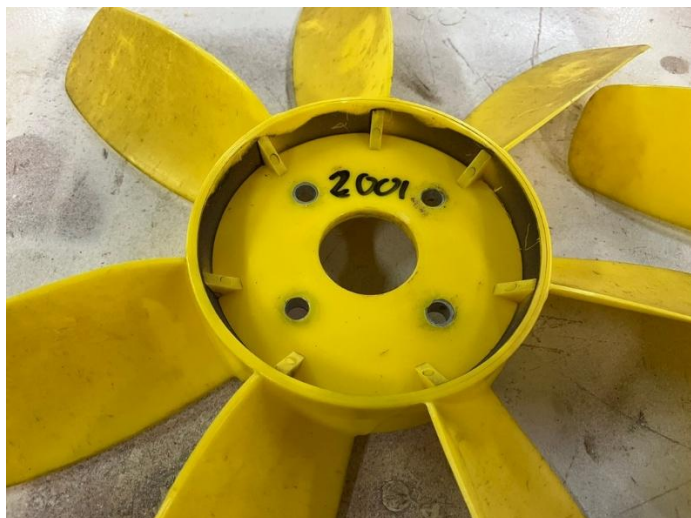
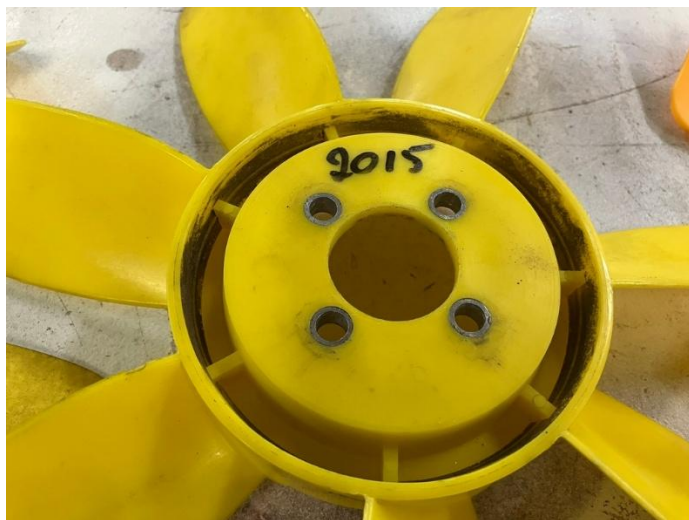
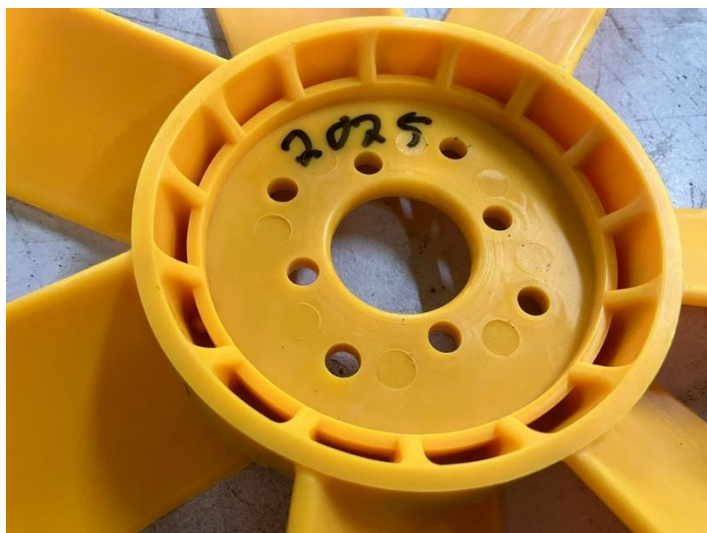
In doing a quick “interweb” search, what was found is losing a fan blade is fairly common with the yellow plastic fans commonly used on MG cars. Further investigation was in order. What Clay found is the area where the blade fractured was a white color. So I did an inspection on my yellow fan and found the root of one of my fan blades also had a white line though not fractured yet. I suspect that the blade was in the beginning stages of weakening. As a precaution Bro Gene also inspected his fan and found no issues. What Clays and my fan have in common is both were purchased in 2015. Bro Gene's fan was purchased around 2001. Though the blades on Gene's fan looked like ours, the hub is different slightly different.

During the research of the fan failure, it was brought out that fans purchased between 2012 and 2018 could be prone to this failure. Some failures caused collateral damage to the hood and radiator. Clay was definitely lucky that his fan failed at a low engine speed.

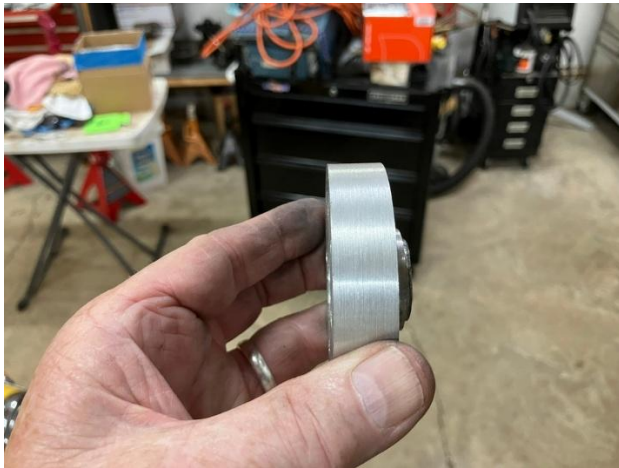
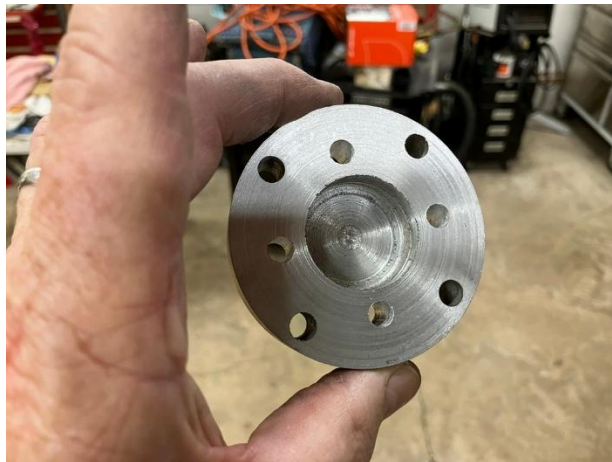
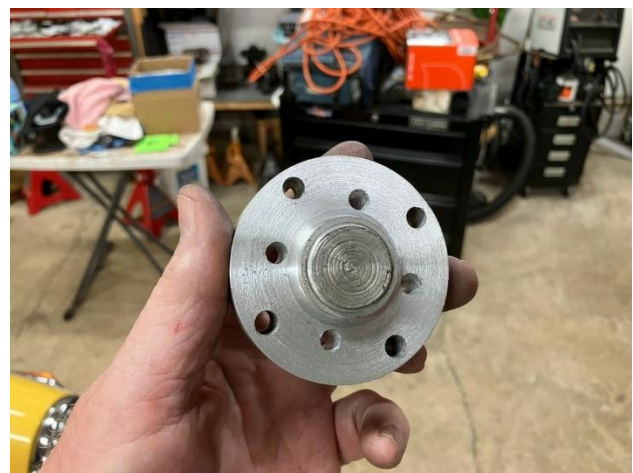
The mount flange in the new fan is displaced by $\frac{5}{8}$ " from the location of the flange in the 2015 yellow plastic fan. To rectify the difference, Moss offers a fan spacer to get the fan blades back to the location of the yellow plastic fan. That may or may not be an issue for some cars. Moss clearly states that the spacer must be used on 72-76 engines equipped with a belt driven air pump. As near as I can tell the 72-76 engines with an air pump have shorter water pump and a cast iron 2 sheave water pump pulley. The hub in the new fan interferes with the front sheave of the pulley. Moss does offer a fan spacer to deal with the $\frac{5}{8}$ " difference. At first I thought I could just machine off that sheave to get clearance. Unfortunately, at less than $\frac{1}{8}$ " clearance, the new placement positioned the fan blades are too close to the crank damper for my liking. So in my case a spacer

would be best. As luck would have it, Bro Gene had a spacer that could be modified to fit. The spacer was the key for my 74 BGT.

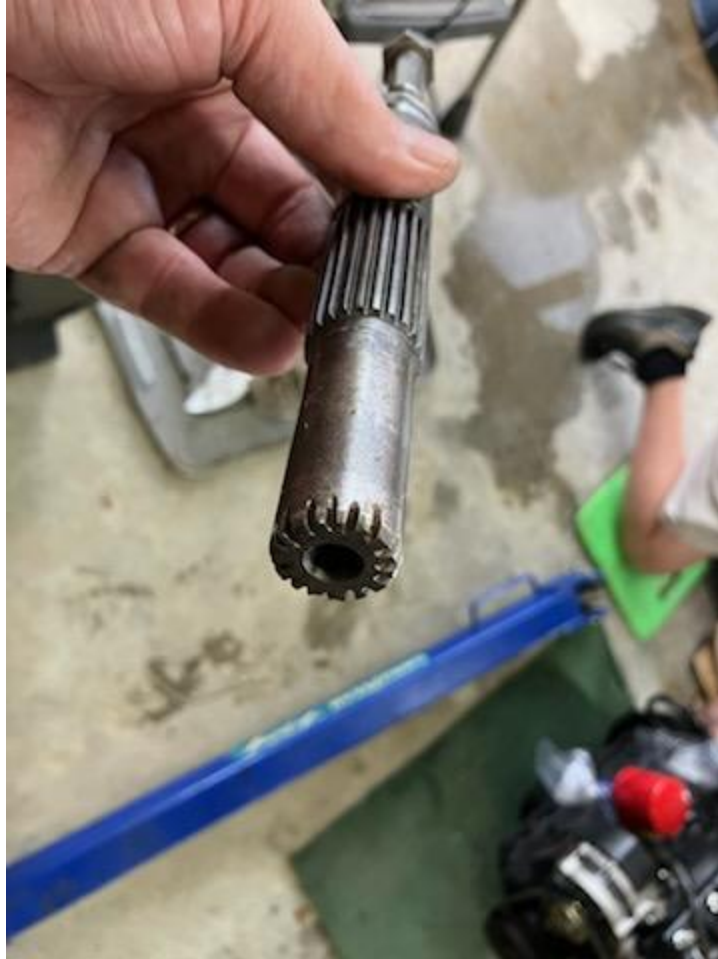
Still working into the evening of the 15th we installed a new aluminum flywheel (why not?), clutch assembly (heavy duty solid disc) and the replacement gearbox. That's when the patient issues developed. We could get the transmission to within an inch of mating with the engine but couldn't get it any closer as hard as we tried. The patient was on life support at this point so at 8:30pm we decided that the staff needed rest. On Monday we determined that the issue was in the pilot bushing. It seems that the nose of the bushing had developed creases or a burr in the nose area and would not allow the gearbox input shaft to seat properly in the bushing. In medical terms, RATS!

Not to be defeated Brother Clay and Charlie modified a spare input shaft that was on hand to allow the reaming of the pilot bushing in place. After 30 minutes of work, we were successful in cleaning up the pilot bushing and on the first attempt the transmission slid into place. The engine/gearbox assembly was re-installed.
