# THE OFF-SIDE UNDO

October 2025

# Opening Pandora's Box

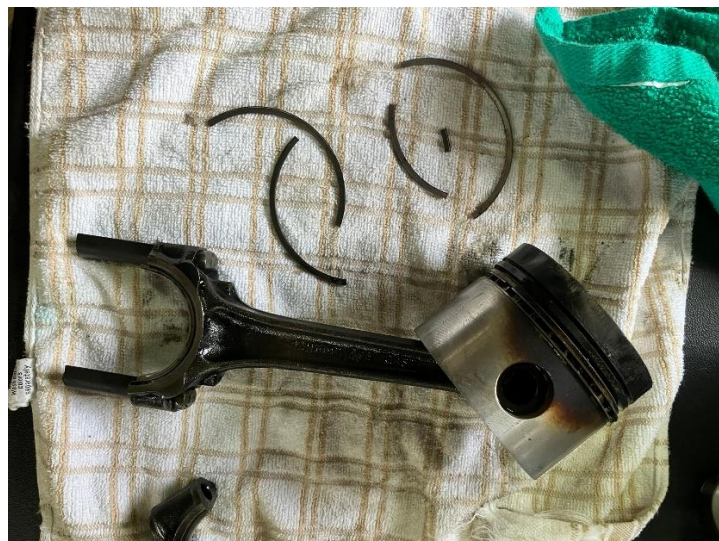
Ever since I purchased my 74 MGB GT the engine has had a strange running issue, a slow idle when warm. I mostly ignored that issue and when the idle slowed I would pull the choke for a faster idle, problem fixed. It also had an erratic oil consumption issue. Sometimes it would use a quart in 30 miles and other times would not use any in 1300 miles. There were rumors about this engine. It had a history of burning pistons. In spite of all of that, the engine ran great and had plenty of power, for me. In a weak moment it decided I would investigate the slow hot idle. I initially thought it could be caused by heat soak of the electronic ignition module or the ignition coil. Those items were eliminated and deemed to be OK. What I did notice was a rough idle when the engine was warm. Using the pull the plug wire one at a time test, it was discovered that #2 cylinder was weaker than the rest of the cylinders. A compression test netted the following numbers in order #1 - 120, #2 -30, #3 - 90, #4 - 120. Seeing those numbers a leak down test was in order. Cylinders 1,3, and 4 had no discernable leakage that could be heard with a rubber hose. However, 2 was leaking badly into the crankcase. Hoping for just a breached head gasket, the head was pulled to investigate. With the head off I was alarmed to see that the head and block sealing surfaces were awash with oil. After cleaning those surfaces, there were clear imprints of all the gasket reinforced sealing rings and no signs of any breaches. It was further found that the black composite areas of the 2-year-old Payen head gasket had never sealed against the block or head. No wonder there was constant oily residue on the engine and engine bay with no obvious oil leak. Apparently, the oil mess was wicking from the pushrod holes and running amuck between block and head. Next step was to check the head for valve leakage. The head was inverted and solvent poured into the combustion chambers. All looked good there. Next was the solvent on top of the pistons test. Cylinders 1, 3, and 4 held fast. The solvent just poured past the rings on #2. That meant something had to be done. With the GT in the "Lotus" position and getting the pan down, Bro Clay pushed the #2 piston out of the hole. That culprit was found. Both top rings were broken!

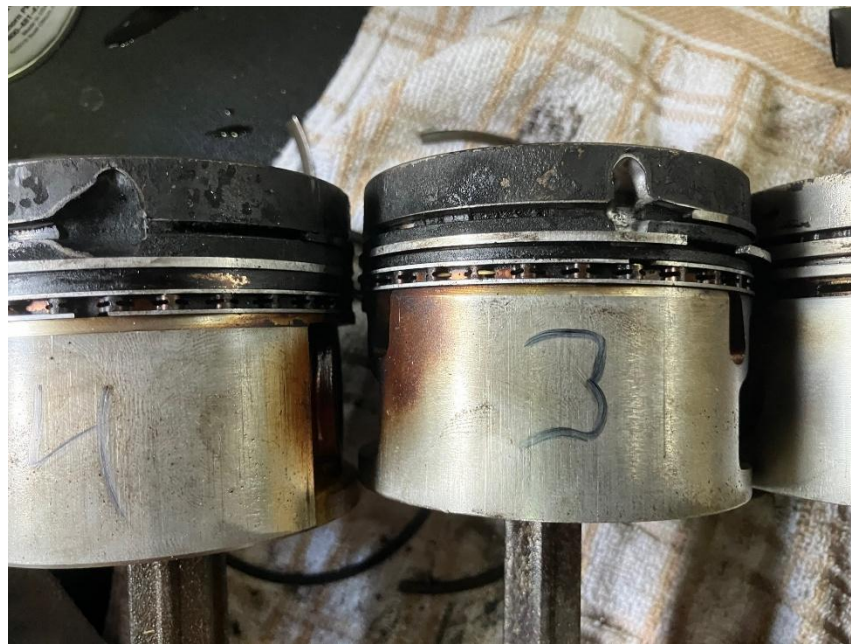
Aside from that the piston looked pretty good and thought was given to re-ring that piston and call it good. But the little voice inside slapped me upside the head. So #3 was pushed out of the hole. That piston also had broken rings, but the ring lands were destroyed by the broken rings. Well, so much for the re-ring idea. Next was #4. That piston also had broken rings and destroyed ring lands. Piston #1 had broken rings also. Also noted there were 3 different brands of pistons in the engine. Perhaps those rumors of burned pistons were true.

Pistons 3 and 4 with damage

At first, it was considered to replace the +040 pistons with a new set of pistons and rings and put the engine back together. To get a better look at the bores, a straight hone was run down the bores. What was found were 2 or 3 ridges in each cylinder and cylinders 3 and 4 had deep gouges in the areas where those pistons were damaged. That made it clear that the engine was running with broken rings for a long time. Since it was unlikely those gouges would clean up with a +060 overbore and the crank was ground undersize at .040 and .020, it was decided to scrap that engine and explore other avenues.

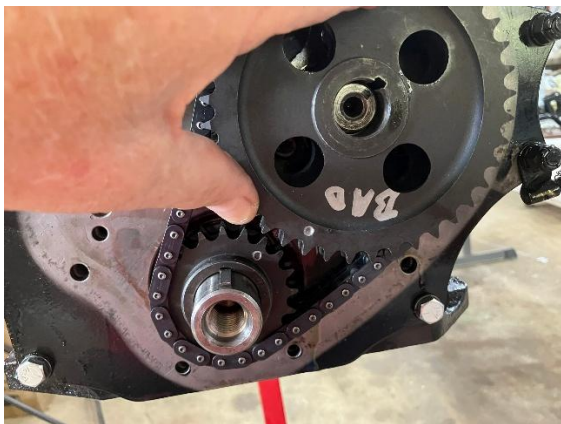
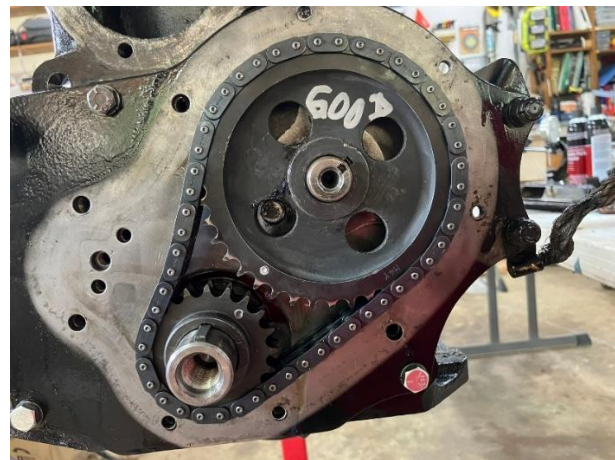
A bad outcome averted

The new cam sprocket was made wrong. The timing mark was off by about 1 and  $\frac{3}{4}$  teeth. The old sprocket was installed, aligned the marks, and the cam timing came in right at the desired 106 degrees. Joe confirmed that all is correct. It is a good thing the decision was made to degree the cam and not just slap in new parts and call it good. That disaster was averted.
