THE OFF-SIDE UNDO

June 2025

English Motoring Club of Mississippi

3 Similar Cars, 3 Different Solutions

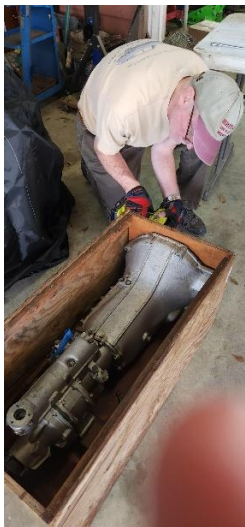
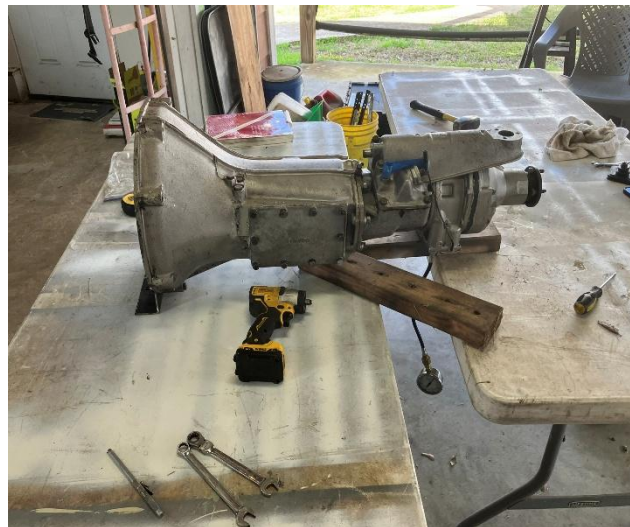
Late in 2024 "Ole Red" my 1971 MG roadster had started developing what I thought were likely clutch and/or transmission issues. Synchros meshing issues and a judder occasionally when backing. I researched as best I could and determined that the clutch assembly was changed sometime back in the early 2000's and in 2014 I'd had a gearbox issue a failed interlocking arm as best I could tell and recall. I sent that box

out for rebuild while I located a replacement overdrive box and installed it into OR. With the clutch reaching 20+ years of service and the gearbox reaching 11 years of service I thought the best plan was to pull the engine, gearbox assembly and replace the clutch and install the gearbox that I'd had rebuilt 11 years previously. A full clutch and gearboxectomy if you will. Charles Durning down in Magee MS offered his outpatient surgical unit as the site for the procedure. Brother Clay Johnston, Charlie and I would perform the operation while the operating theater (the peanut gallery) would be occupied, at least during the initial stages by Will Ducan, Tom Brown and Keith Anderson. Tom politely provided the peanuts which were very good.

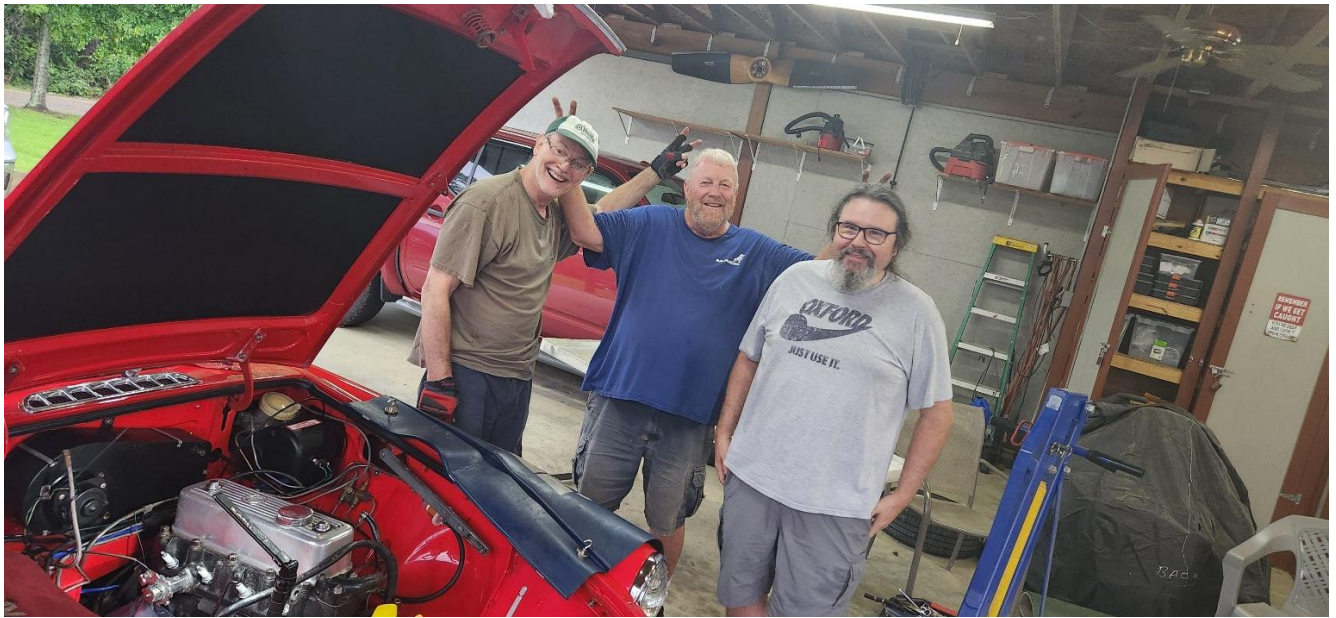
On Sunday afternoon, the 15th of June we were successful in the removal of the assembly. Our evaluation of the clutch disc and throw-out bearing (carbon type) determined that both were in remarkably good condition and likely could have gone many more miles if not years. Hmmmm. Dad had always told me to keep my foot off the clutch and well, evidently although not being too attentive to some of his advice had listened to this one.

Still working into the evening of the 15th we installed a new aluminum flywheel (why not?), clutch assembly (heavy duty solid disc) and the replacement gearbox. That's when the patient issues developed. We could get the transmission to within an inch of mating with the engine but couldn't get it any closer as hard as we tried. The patient was on life support at this point so at 8:30pm we decided that the staff needed rest. On Monday we determined that the issue was in the pilot bushing. It seems that the nose of the bushing had developed creases or a burr in the nose area and would not allow the gearbox input shaft to seat properly in the bushing. In medical terms, RATS!
