# THE OFF-SIDE UNDO

October 2025

# Opening Pandora's Box

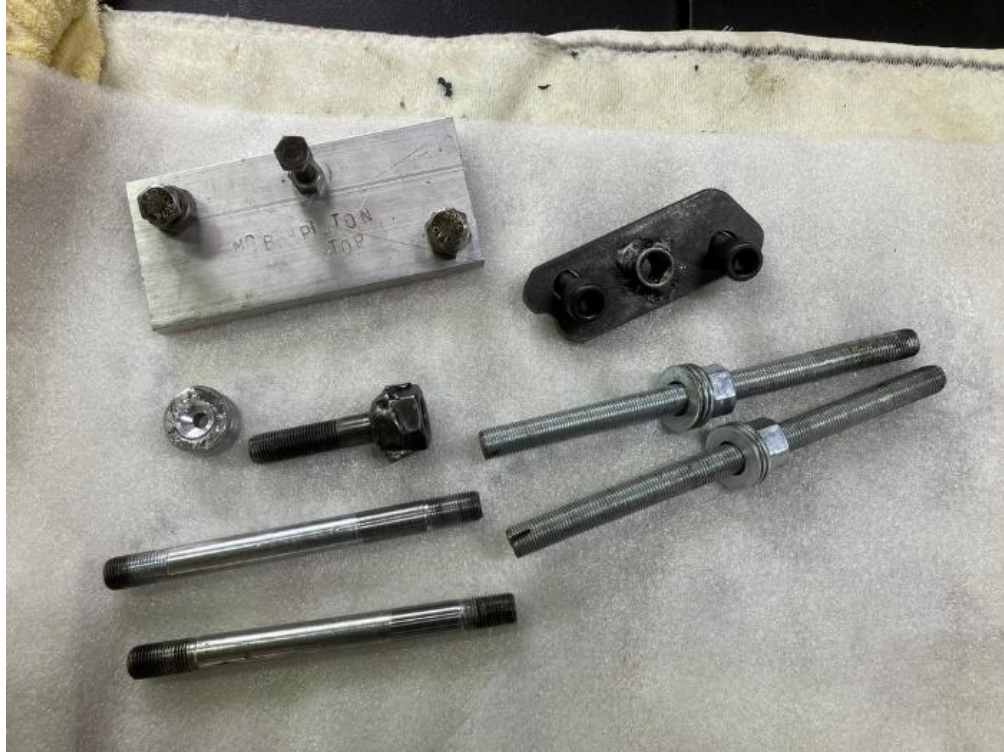
Assortment of custom fabricated tools

Now it is much easier to control the cap while compressing the spring. Before any real assembly could occur, the crankshaft had to be laid in the block. The new bearing inserts were installed and the #2, #3 and #4 main caps installed. The challenge here was with the #1 and #5 main caps. For those there is about a  $3''$  press fit between the cap and the block. That means there is lots of room for misalignment during installation. To solve that problem I made a set of alignment pins out of a pair long studs intended for mounting the front cross member to the car's frame. Using a buddy's lathe the studs were modified for the task. The smooth bodies of those studs would allow for a proper alignment of the main caps as they are installed. Once the alignment was established, I needed a way to press the main caps home without using a mallet. That was solved by removing the alignment studs and replacing them with all thread studs. With the addition of some washers and nuts the caps were evenly pressed into place.

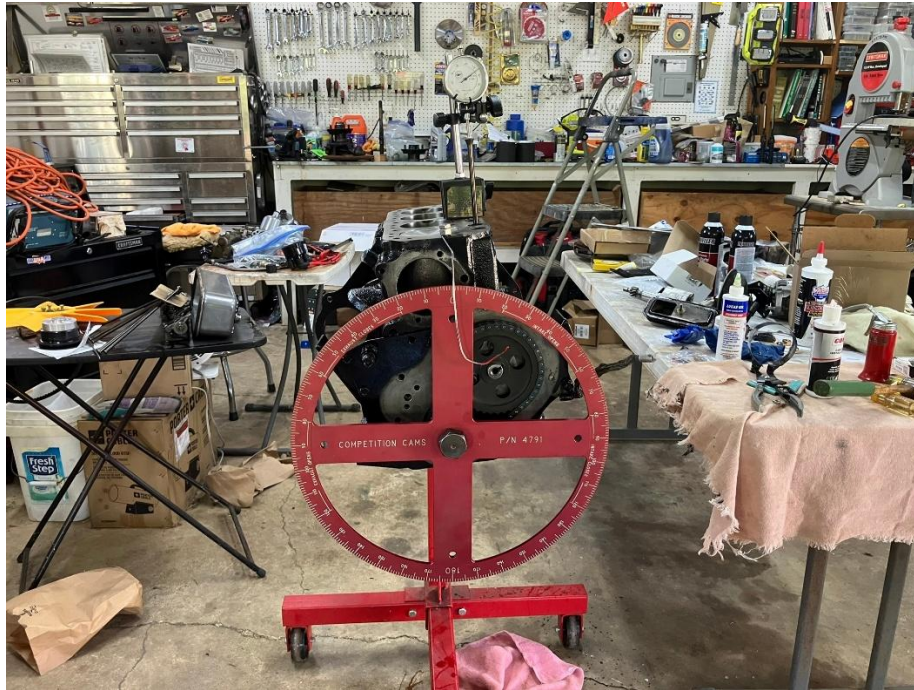
Once the engine was assembled, Bro Clay and Bro Gene came by to help install the engine and transmission back into the GT. With their help the install went smoothly.
